**Flood Control Project Maintenance  
Levee Inspections**  
**LMA District Cover Sheet**  
**Spring 2017 Levee Inspection Results**

**Reclamation District No. 0999 Netherlands**

**Spring 2017 Levee Inspection Results**

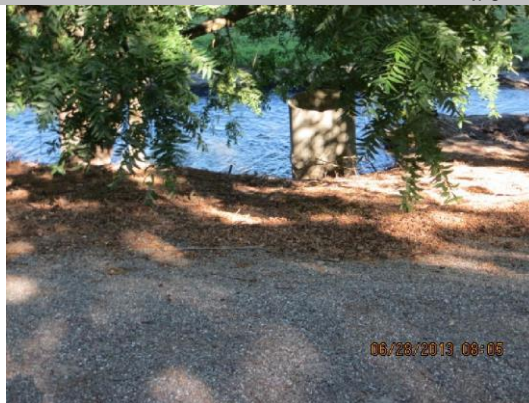
Photo 3 of 3 : UCIP\_SP\_2017\_50093\_25330.jpg

Item	DWR UCIP Field Study			38.363420 °		38.363420 °
				-121.563102 °		-121.563102 °
DWR ID						
Comment Code						
Inspector Comment						
FS_ID:50093 DS_ID:22849 EP_NO: 7378 Repair Type: Urgent Crossing Status: Found UCIP Comments: 07/07/2016 - LS toe of levee still has erosion around stand pipe and adjacent oak tree. Erosion does not appear to be any worse than during previous inspection. no water in canal on LS toe led to the discovery of two additional appurtenant structures. (T. Hatch/UCIP)06/28/2013 - Pipe outlet is eroding the LS slope of the levee, exposing the roots of an oak and threatening greater damage if allowed to continue. (W. Wylie/UCIP) FIELD_STRUCT_DESC: 10-inch steel irrigation pipe through the levee, 6 feet below the crown. Slant pump and service pole on the waterside (WS) slope. 36-inch concrete standpipe on the landside (LS) toe (Permit No. 7378, 1971 - Volz). Replaced an existing 8-inch pipe at the same location. [Additional Reference(s): DWR Levee Logs, 1992]. FS Date: 7/7/2016

36-inch concrete standpipe on LS toe.

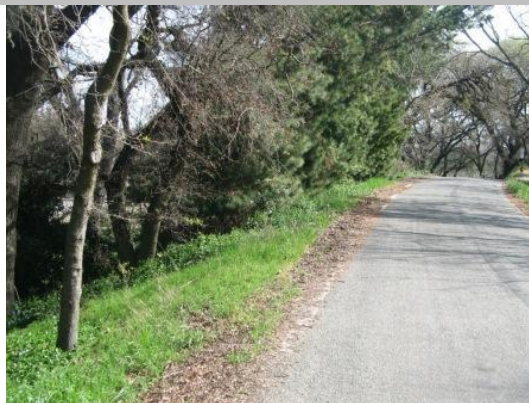
Photo 1 of 1 : SP\_2017\_RD0999\_236\_31\_20170314\_00027.jpg

LM Start	3.12	Rating **	M	Issue No.	31
LM End	3.17	Issue Type +	En	Location *	LS
Category	Earthen Levee			GPS Latitude/Longitude	
				Start	End
Item	Vegetation			38.364392 °	38.364597 °
				-121.561882 °	-121.561087 °
DWR ID	DWR_RD0999_05_s_2012_31				
Comment Code					
V6 : Landscaping					
Inspector Comment

Looking downstream of landscaping blocking view of landside slope.

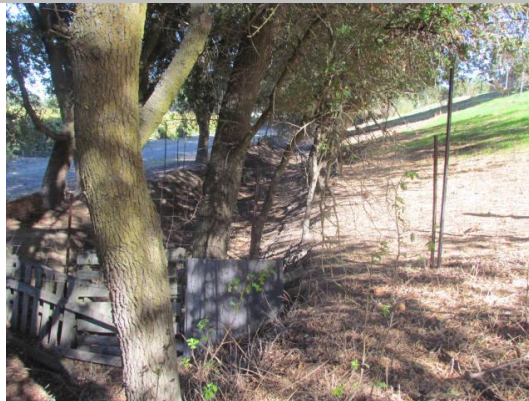
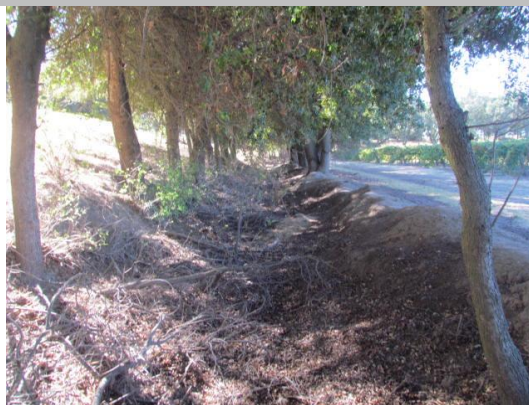
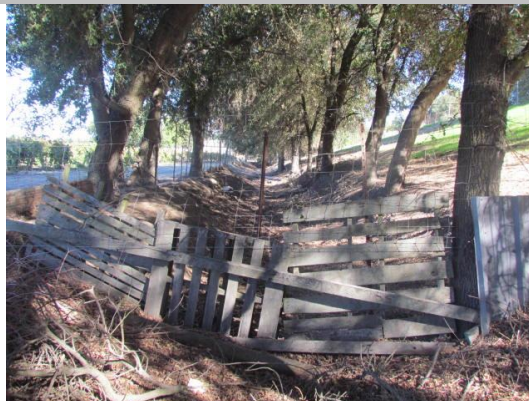
LM Start	3.21	Rating **	M	Issue No.	153
LM End	4.22	Issue Type +	En	Location *	LS
Category	Earthen Levee			GPS Latitude/Longitude	
				Start	End
Item	Encroachments			38.364694 °	38.372513 °
				-121.560209 °	-121.552538 °
DWR ID	DWR_RD0999_05_f_2013_153				
Comment Code					
DT : Ditch					
Inspector Comment					
Adandoned irrigation ditch at landward toe.

Looking north at old irrigation ditch at landward toe.

Looking south at irrigation ditch at landward toe.

Looking north at irrigation ditch at landward toe.

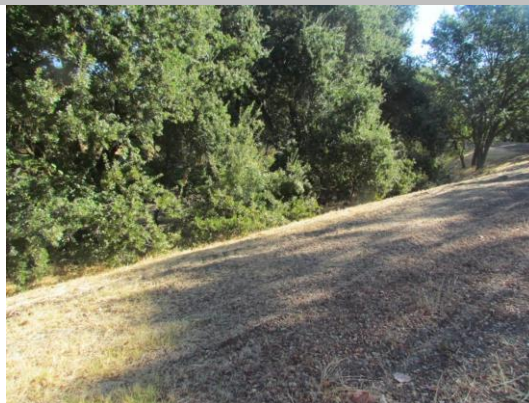
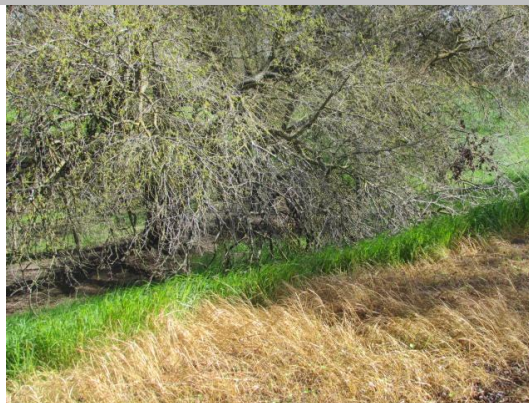
LM Start	3.39	Rating **	U	Issue No.	213
LM End	3.39	Issue Type +	Ma	Location *	LS
Category	Earthen Levee			GPS Latitude/Longitude	
				Start	End
Item	Trim / Thin Trees			38.363906 °	38.363906 °
				-121.557220 °	-121.557220 °
DWR ID	DWR_RD0999_05_s_2016_213				
Comment Code					
T1 : Trim trees to at least five feet above ground level.					
Inspector Comment

Looking northwest at untrimmed trees on landward toe. (Fall 2016)

Looking northwest at untrimmed trees at landward toe. (Spring 2016)

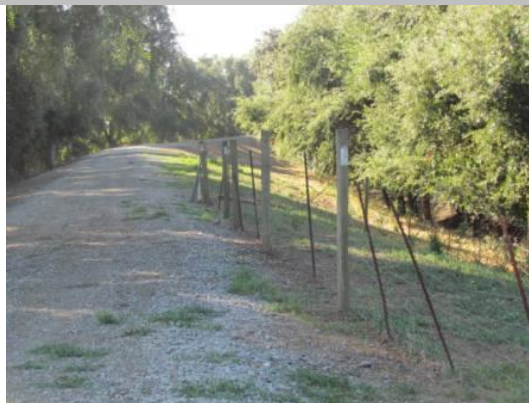
Photo 1 of 1 : SP\_2017\_RD0999\_236\_83\_20170314\_00067.jpg

LM Start	3.55	Rating **	M	Issue No.	83
LM End	3.65	Issue Type +	En	Location *	LS
Category	Earthen Levee			GPS Latitude/Longitude	
				Start	End
Item	Encroachments			38.365711 °	38.367107 °
				-121.556714 °	-121.556745 °
DWR ID	DWR_RD0999_05_s_2012_83				
Comment Code					
FE : Fence					
Inspector Comment					
Fencing on landward slope.

Looking north at fence along waterside shoulder.

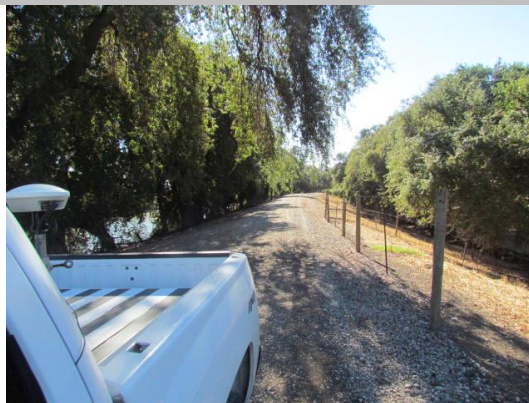
Photo 1 of 1 : SP\_2017\_RD0999\_236\_173\_20170314\_00116.jpg

LM Start	3.56	Rating **	M	Issue No.	173
LM End	3.56	Issue Type +	Ma	Location *	WS
Category	Earthen Levee			GPS Latitude/Longitude	
				Start	End
Item	Trim / Thin Trees			38.365882 °	38.365882 °
				-121.556762 °	-121.556762 °
DWR ID	DWR_RD0999_05_f_2015_173				
Comment Code					
T4 : Trim trees over roadway to at least 12 feet above ground level.					
Inspector Comment

Looking at the tree overhanging the levee crown.

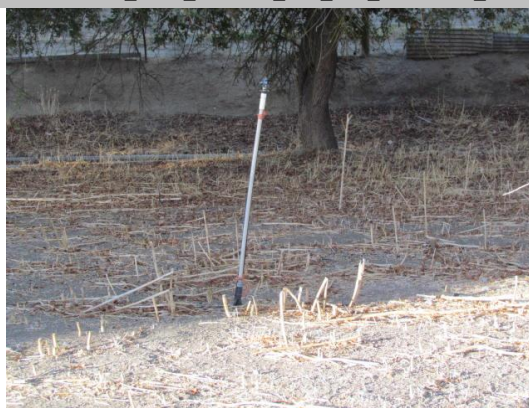
Photo 1 of 1 : SP\_2017\_RD0999\_236\_202\_20170314\_00142.jpg

LM Start	3.58	Rating **	M	Issue No.	202
LM End	3.64	Issue Type +	En	Location *	LS
Category	Earthen Levee			GPS Latitude/Longitude	
				Start	End
Item	Encroachments			38.366100 °	38.367043 °
				-121.556831 °	-121.556772 °
DWR ID	DWR_RD0999_05_f_2014_202				
Comment Code					
LI : Landscape Irrigation					
Inspector Comment					
Landowner installed sprinkler system on landward slope.

Looking west at one of several sprinklers installed on landward slope.

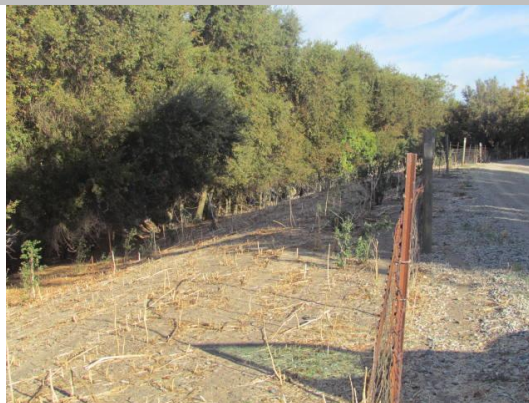
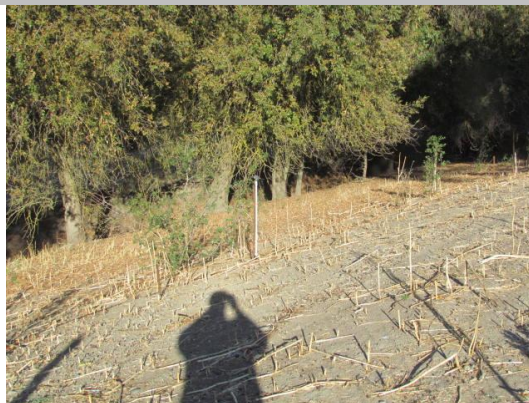
LM Start	3.58	Rating **	M	Issue No.	201
LM End	3.64	Issue Type +	Ma	Location *	LS
Category	Earthen Levee			GPS Latitude/Longitude	
				Start	End
Item	Trim / Thin Trees			38.366103 °	38.367035 °
				-121.556820 °	-121.556781 °
DWR ID	DWR_RD0999_05_f_2014_201				
Comment Code					
T2 : Thin trees to allow visibility of the ground and room to flood fight.					
Inspector Comment					
Landowner has planted oak trees and installed sprinklers on landward slope. Oak trees should be removed.

Looking northwest at several small oak trees planted along landward slope.

Looking west a several small oak trees planted on landward slope.

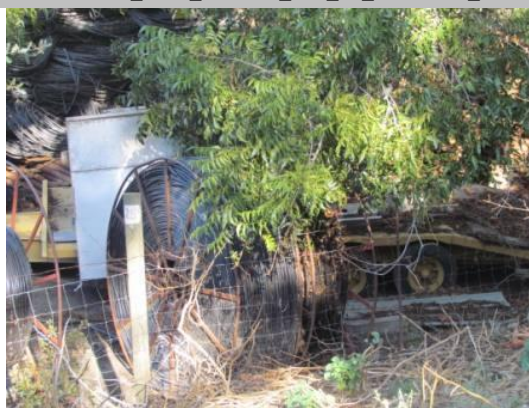
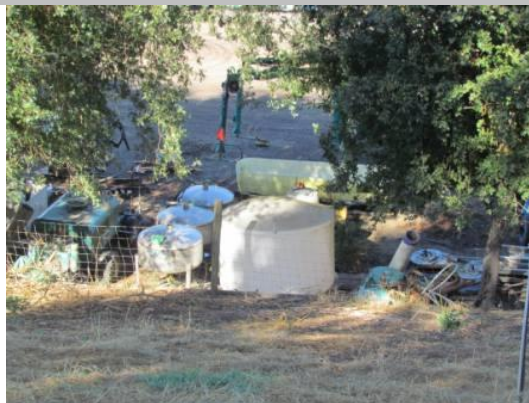
LM Start	3.64	Rating **	M	Issue No.	16
LM End	3.64	Issue Type +	Ma	Location *	LS
Category	Earthen Levee			GPS Latitude/Longitude	
				Start	End
Item	Encroachments			38.366958 °	38.366958 °
				-121.556822 °	-121.556822 °
DWR ID	DWR_RD0999_05_s_2012_16				
Comment Code					
EQ : Equipment					
Inspector Comment					
Equipment stored at landward toe.

Looking northwest at equipment on landside toe.

Looking west at equipment at landside toe.

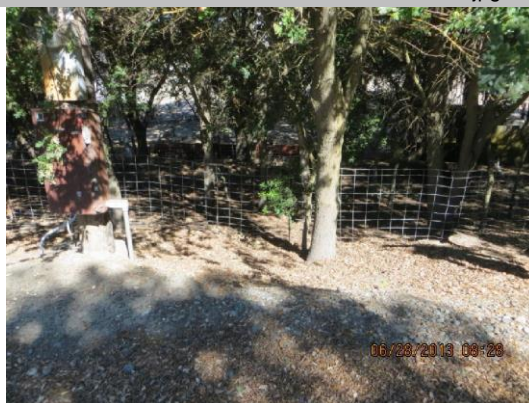
Photo 2 of 3 : UCIP\_SP\_2017\_16337\_27534.jpg

LM Start	3.67	Rating **	M	Issue No.	236
LM End	3.67	Issue Type +	En	Location *	LS
Category	Supplemental			GPS Latitude/Longitude	
				Start	End
Item	DWR UCIP Field Study			38.367469 °	38.367469 °
				-121.556509 °	-121.556509 °
DWR ID					
Comment Code					
Inspector Comment					
FS_ID:16337					
DS_ID:23965					
EP_NO: N/A					
Repair Type: Non-Urgent					
Crossing Status: Found					
UCIP Comments: Need to determine permit No. for this crossing.					
FIELD_STRUCT_DESC: 9-inch steel irrigation pipe through levee 2-feet below crown. Pump on pier on WS with butterfly valve. Filter plant and siphon breaker on LS toe 1.5-inch galvanized iron electrical at same location.					
FS Date: 6/28/2013

LM Start	<b>3.67</b>	Rating **	M	Issue No.	<b>236 (cont)</b>
LM End	<b>3.67</b>	Issue Type +	En	Location *	LS

1.5-inch galvanized iron electrical conduit at same location.

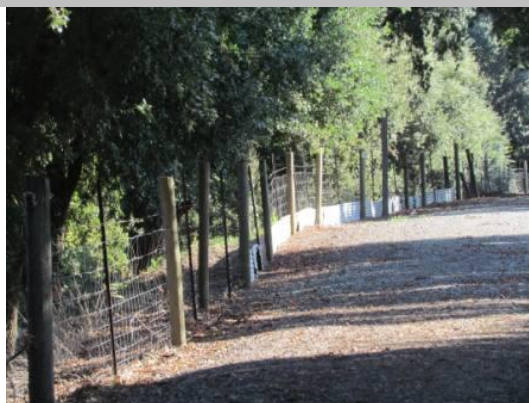
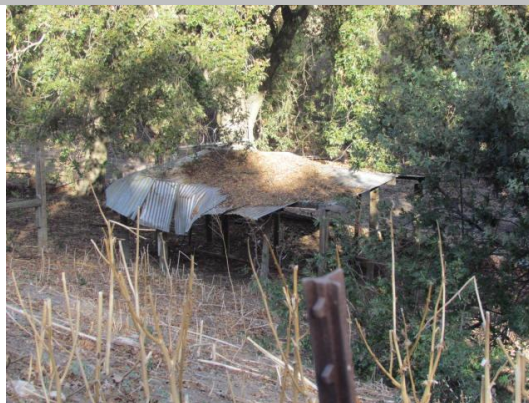
LM Start	3.68	Rating **	M	Issue No.	85
LM End	3.75	Issue Type +	En	Location *	LS
Category	Earthen Levee			GPS Latitude/Longitude	
				Start	End
Item	Encroachments			38.367500 °	38.367997 °
				-121.556478 °	-121.555348 °
DWR ID	DWR_RD0999_05_s_2012_85				
Comment Code					
FE : Fence					
Inspector Comment					
Fencing is for livestock.

Looking north at fence along landside shoulder.

Looking west at animal shelter within animal pen on landward slope.

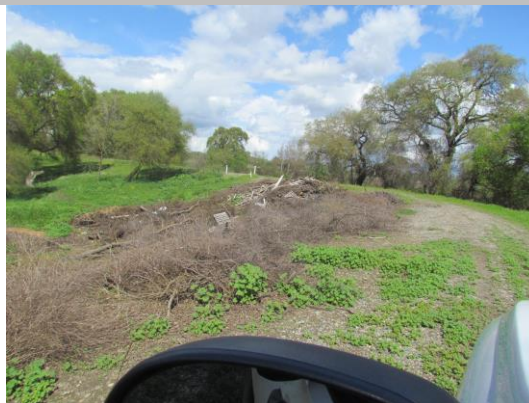
Photo 1 of 2 : SP\_2017\_RD0999\_236\_17\_20170324\_00241.jpg

LM Start	3.88	Rating **	U	Issue No.	17
LM End	3.88	Issue Type +	En	Location *	LS
Category	Earthen Levee			GPS Latitude/Longitude	
				Start	End
Item	Encroachments			38.368307 °	38.368307 °
				-121.552955 °	-121.552955 °
DWR ID	DWR_RD0999_05_s_2012_17				
Comment Code					
PR : Prunings					
Inspector Comment					
Large pruning pile on landward toe and slope.

Looking northwest at large pruning pile on landward slope. (Spring 2017)

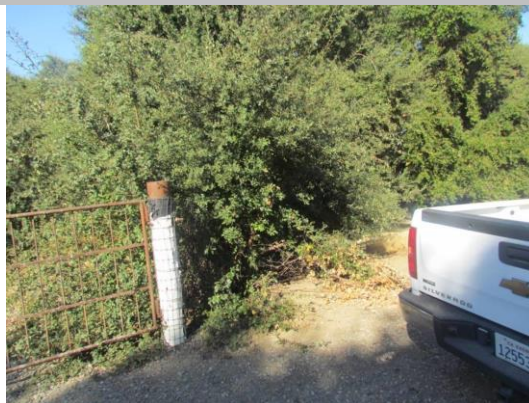
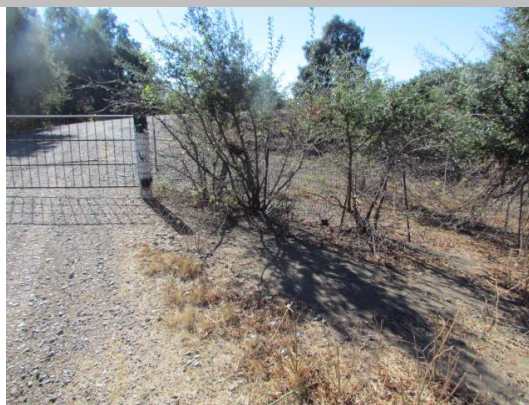
LM Start	3.94	Rating **	U	Issue No.	175
LM End	3.94	Issue Type +	Ma	Location *	LS
Category	Earthen Levee			GPS Latitude/Longitude	
				Start	End
Item	Trim / Thin Trees			38.368928 °	38.368928 °
				-121.552473 °	-121.552473 °
DWR ID	DWR_RD0999_05_f_2015_175				
Comment Code					
T2 : Thin trees to allow visibility of the ground and room to flood fight.					
Inspector Comment					
Thin or remove young tree from landward shoulder and slope.

Looking west at untrimmed trees along fence line on landward slope.  
(Fall 2016)

Looking at young trees on waterward shoulder and slope. (Spring 2016)

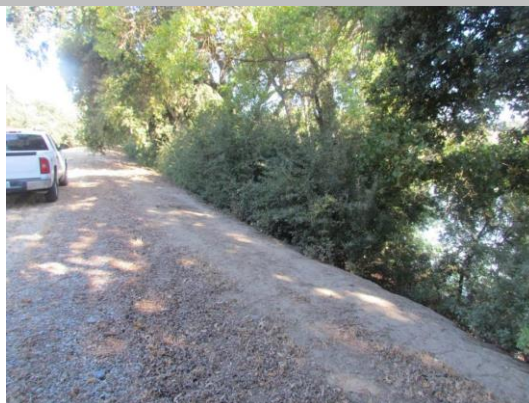
Photo 1 of 1 : SP\_2017\_RD0999\_236\_41\_20170314\_00034.jpg

LM Start	3.98	Rating **	U	Issue No.	41
LM End	4.05	Issue Type +	Ma	Location *	WS
Category	Earthen Levee			GPS Latitude/Longitude	
				Start	End
Item	Trim / Thin Trees			38.369440 °	38.370398 °
				-121.552747 °	-121.553373 °
DWR ID	DWR_RD0999_05_s_2012_41				
Comment Code					
T3 : Trim and thin trees to allow visibility of the ground and room to flood fight.					
Inspector Comment					
Control oak saplings on waterward slope.

Looking northeast at untrimmed trees on waterward slope.

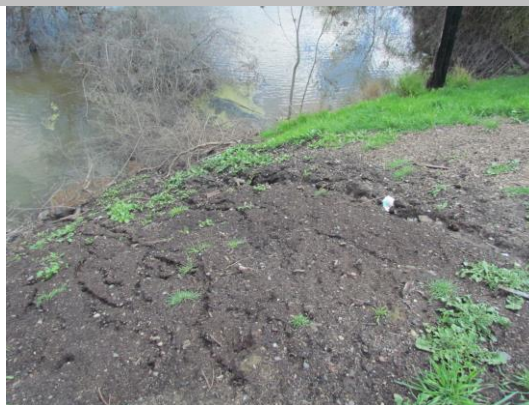
Photo 2 of 2 : SP\_2017\_RD0999\_236\_12\_20170324\_00243.jpg

LM Start	4.25	Rating **	U	Issue No.	12
LM End	4.25	Issue Type +	Ma	Location *	WS
Category	Earthen Levee			GPS Latitude/Longitude	
				Start	End
Item	Slope Stability			38.372872 °	38.372872 °
				-121.552185 °	-121.552185 °
DWR ID	DWR_RD0999_05_s_2017_12				
Comment Code					
S1 : Repair slope instability.					
Inspector Comment					
Large slough on waterward slope.

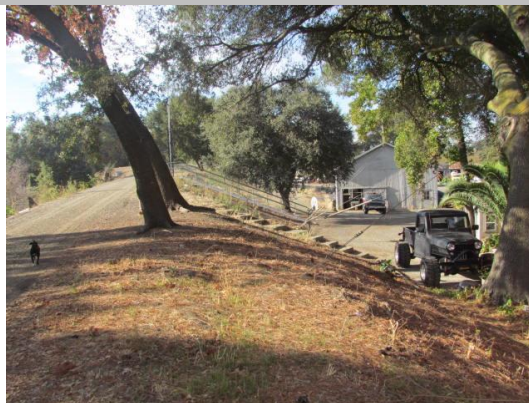
Photo 1 of 4 : SP\_2017\_RD0999\_236\_44\_20170314\_00037.jpg

Looking south at corrected landscaping on landward slope.

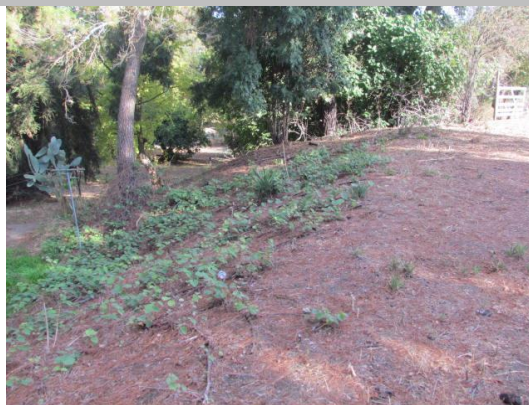
Photo 2 of 4 : SP\_2017\_RD0999\_236\_44\_20170314\_00038.jpg

Looking north at corrected landscaping on landward slope.

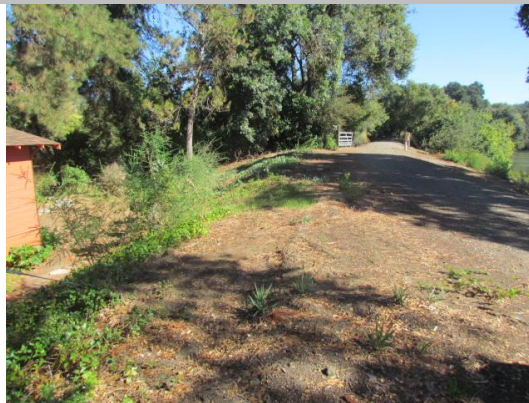
Photo 3 of 4 : SP\_2017\_RD0999\_236\_44\_20170314\_00039.jpg

Looking north at landscaping on landward slope.

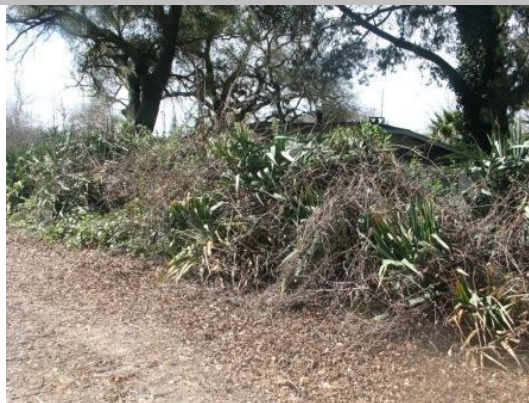
Photo 4 of 4 : SP\_2017\_RD0999\_236\_44\_20170314\_00040.jpg

LM Start	4.30	Rating **	A/W	Issue No.	44 (cont)	
LM End	4.33	Issue Type +	En	Location *	LS	
Category	Earthen Levee			GPS Latitude/Longitude		
				Start		End
Item	Vegetation			38.373625 °		38.373907 °
				-121.551787 °		-121.551607 °
DWR ID	DWR_RD0999_05_s_2012_44					
Comment Code						
V6 : Landscaping						
Inspector Comment						
Landowner complies with Board standards.

Overgrown landscaping on landside slope blocking view of slope.

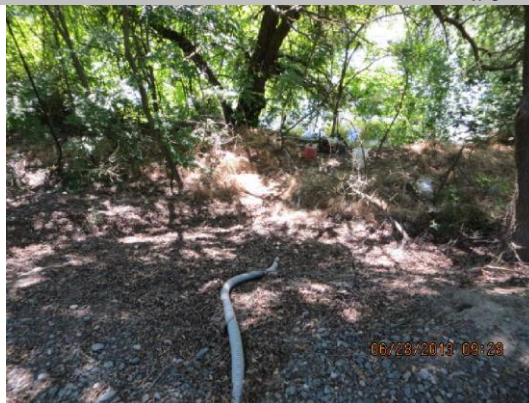
Photo 1 of 2 : UCIP\_SP\_2017\_16338\_27538.jpg

LM Start	4.36	Rating **	M	Issue No.	237
LM End	4.36	Issue Type +	En	Location *	WS
Category	Supplemental			GPS Latitude/Longitude	
				Start	End
Item	DWR UCIP Field Study			38.374376 °	38.374376 °
				-121.551201 °	-121.551201 °
DWR ID					
Comment Code					
Inspector Comment					
FS_ID:16338 DS_ID:23966 EP_NO: N/A Repair Type: Non-Urgent Crossing Status: Found UCIP Comments: This crossing should be permitted or removed. FIELD_STRUCT_DESC: 2-inch plastic water line through the levee 6-inch below the crown. Portable pump on the WS toe. FS Date: 6/28/2013

Flex pipe through the levee 6-inches below the crown with portable pump on WS toe.

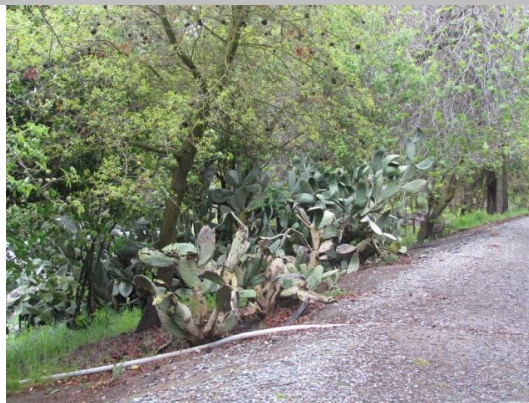
Photo 1 of 1 : SP\_2017\_RD0999\_236\_56\_20170314\_00049.jpg

LM Start	4.37	Rating **	M	Issue No.	56
LM End	4.37	Issue Type +	En	Location *	LS
Category	Earthen Levee			GPS Latitude/Longitude	
				Start	End
Item	Vegetation			38.374410 °	38.374410 °
				-121.551173 °	-121.551173 °
DWR ID	DWR_RD0999_05_s_2012_56				
Comment Code					
V6 : Landscaping					
Inspector Comment					
Cactus

Looking northwest at cactus on landside shoulder and slope. (Spring 2012)

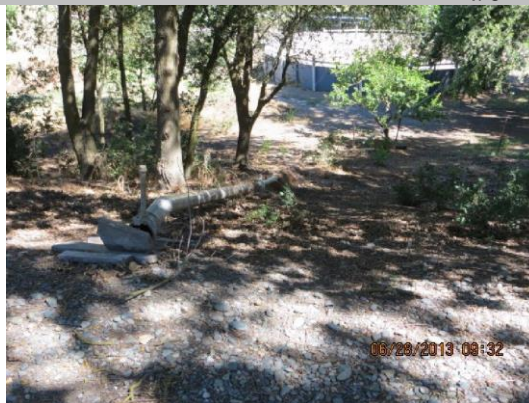
Photo 1 of 3 : UCIP\_SP\_2017\_16403\_27686.jpg

LM Start	4.45	Rating **	M	Issue No.	238
LM End	4.45	Issue Type +	En	Location *	LS
Category	Supplemental			GPS Latitude/Longitude	
				Start	End
Item	DWR UCIP Field Study			38.375036 °	38.375036 °
				-121.549961 °	-121.549961 °
DWR ID					
Comment Code					
Inspector Comment					
FS_ID:16403 DS_ID:23967 EP_NO: N/A Repair Type: Non-Urgent Crossing Status: Found UCIP Comments: Need to determine Permit No. for this crossing or remove it. FIELD_STRUCT_DESC: 5-inch temporary alluminum pipe over the top of the levee. Portable pump on the WS toe. FS Date: 6/28/2013

Pipe on LS slope.

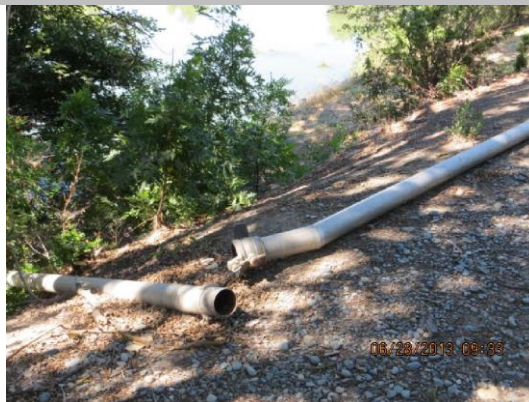
Photo 2 of 3 : UCIP\_SP\_2017\_16403\_27685.jpg

Pipe on WS slope.

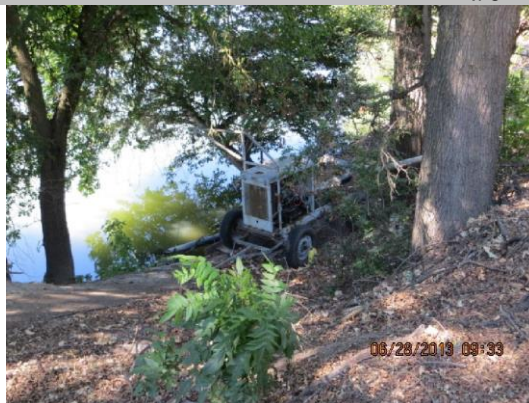
Photo 3 of 3 : UCIP\_SP\_2017\_16403\_27687.jpg

LM Start	4.45	Rating **	M	Issue No.	238 (cont)
LM End	4.45	Issue Type +	En	Location *	LS
Category	Supplemental			GPS Latitude/Longitude	
				Start	End
Item	DWR UCIP Field Study			38.375036 °	38.375036 °
				-121.549961 °	-121.549961 °
DWR ID					
Comment Code					
Inspector Comment					
FS_ID:16403 DS_ID:23967 EP_NO: N/A Repair Type: Non-Urgent Crossing Status: Found UCIP Comments: Need to determine Permit No. for this crossing or remove it. FIELD_STRUCT_DESC: 5-inch temporary alluminum pipe over the top of the levee. Portable pump on the WS toe. FS Date: 6/28/2013

Portable pump on WS toe.

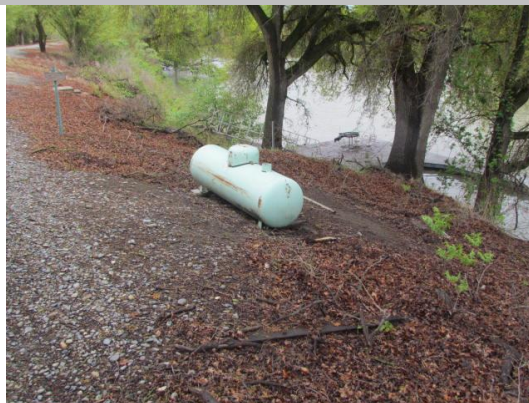
Photo 1 of 1 : SP\_2017\_RD0999\_236\_131\_20170314\_00089.jpg

LM Start	4.45	Rating **	M	Issue No.	131
LM End	4.45	Issue Type +	En	Location *	WS
Category	Earthen Levee			GPS Latitude/Longitude	
				Start	End
Item	Encroachments			38.375027 °	38.375027 °
				-121.549883 °	-121.549883 °
DWR ID	DWR_RD0999_05_s_2012_131				
Comment Code					
EQ : Equipment					
Inspector Comment					
Propane tank on waterside slope within the twenty foot zone.

Looking northeast at propane tank on waterside slope.

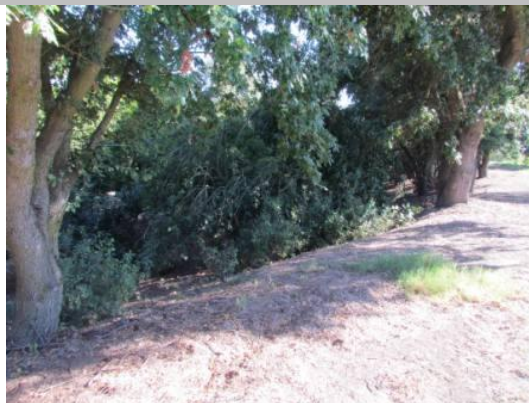
Photo 1 of 3 : SP\_2017\_RD0999\_236\_38\_20170314\_00029.jpg

Looking northwest at dense trees on landside slope. (Spring 2011)

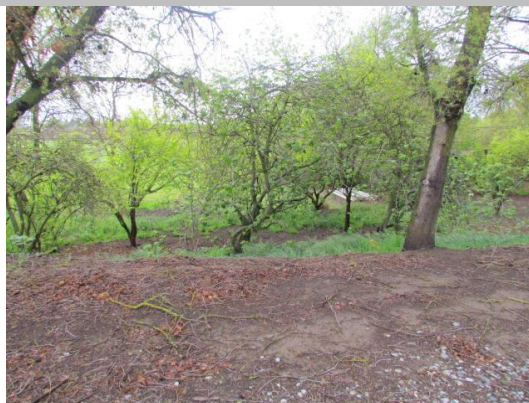
Photo 2 of 3 : SP\_2017\_RD0999\_236\_38\_20170314\_00030.jpg

Looking west at trimmed trees on landside slope. (Spring 2012)

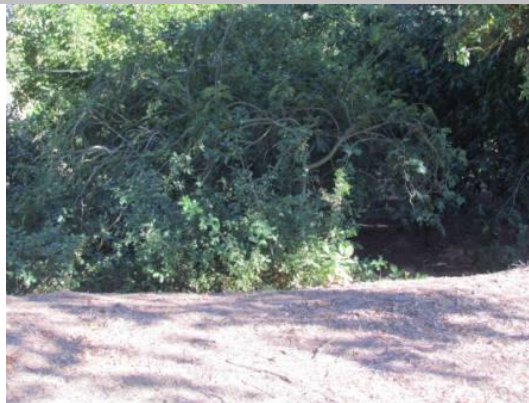
Photo 3 of 3 : SP\_2017\_RD0999\_236\_38\_20170314\_00031.jpg

Looking west at dense trees on landside slope. (Spring 2011)

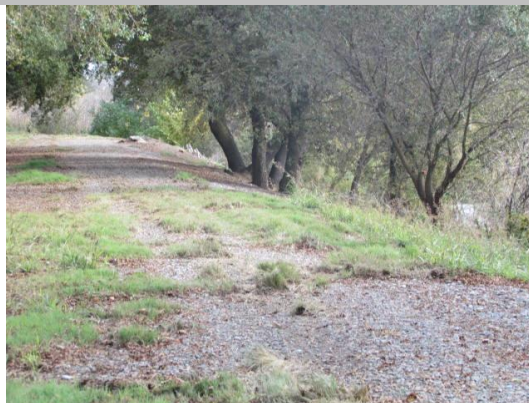
Photo 1 of 1 : SP\_2017\_RD0999\_236\_32\_20170314\_00028.jpg

LM Start	4.51	Rating **	M	Issue No.	32
LM End	4.85	Issue Type +	Ma	Location *	CR
Category	Earthen Levee			GPS Latitude/Longitude	
				Start	End
Item	Crown Surface / Depressions / Rutting			38.375084 °	38.377176 °
				-121.548750 °	-121.543571 °
DWR ID	DWR_RD0999_05_f_2012_32				
Comment Code					
C1 : Add appropriate material and re-grade the levee to bring the crown above the design elevation.					
Inspector Comment

Looking north at vegetation on levee crown.

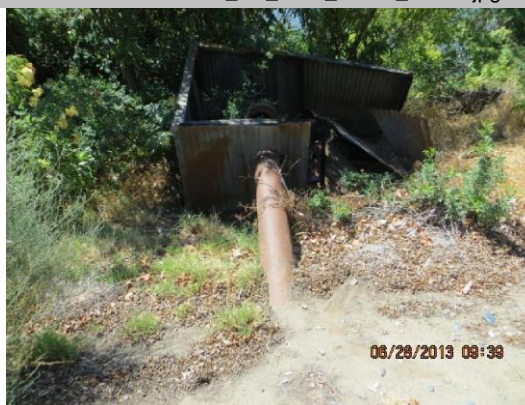
Photo 1 of 3 : UCIP\_SP\_2017\_15443\_25362.jpg

LM Start	4.69	Rating **	M	Issue No.	239
LM End	4.69	Issue Type +	En	Location *	WS
Category	Supplemental			GPS Latitude/Longitude	
				Start	End
Item	DWR UCIP Field Study			38.375537 °	38.375537 °
				-121.545647 °	-121.545647 °
DWR ID					
Comment Code					
Inspector Comment					
FS_ID:15443					
DS_ID:22882					
EP_NO: 7383					
Repair Type: Non-Urgent					
Crossing Status: Found					
UCIP Comments: Pipe abandoned and should be done so properly.					
FIELD_STRUCT_DESC: 10-inch steel irrigation pipe through the levee					
4.0 feet below the crown. Pumphouse on WS slope and a JP on the LS					
shoulder. 1.5-inch galvanized iron electrical conduit at same location.					
Replaces existing portion of a 10-inch pipe within the levee section					
(Permit No. 7383, 1971).					
FS Date: 6/28/2013

Abandoned pumphouse on WS slope.

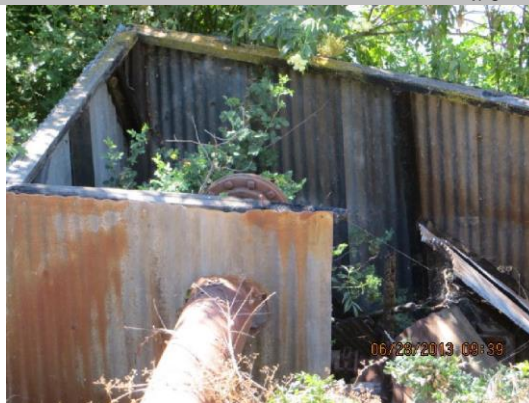
Photo 2 of 3 : UCIP\_SP\_2017\_15443\_25361.jpg

Abandoned pumphouse on WS slope.

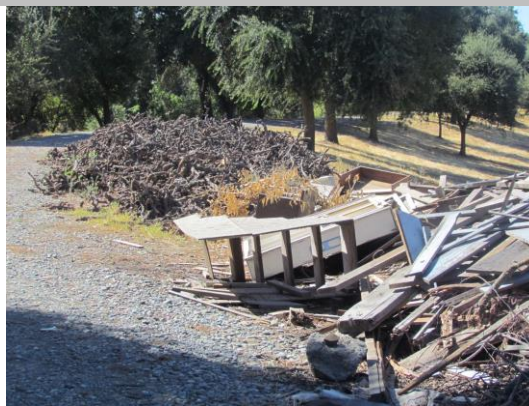
Photo 1 of 2 : SP\_2017\_RD0999\_236\_65\_20170314\_00052.jpg

LM Start	5.07	Rating **	A/W	Issue No.	65
LM End	5.07	Issue Type +	Ma	Location *	LS
Category	Earthen Levee			GPS Latitude/Longitude	
				Start	End
Item	Encroachments			38.379711 °	38.379711 °
				-121.541070 °	-121.541070 °
DWR ID	DWR_RD0999_05_s_2012_65				
Comment Code					
PR : Prunings					
Inspector Comment					
Prunings and garbage pile on landside shoulder and slope.

Looking south at prunings and garbage on landward shoulder and slope. (Fall 2016)

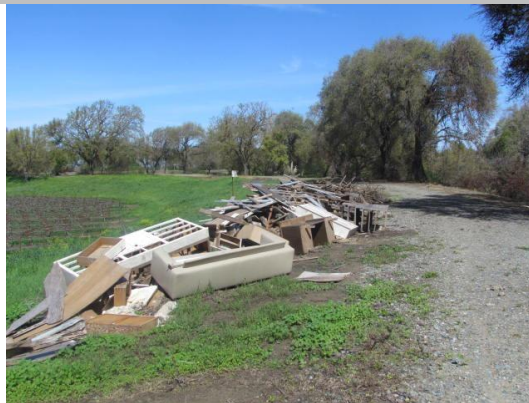
Photo 2 of 2 : SP\_2017\_RD0999\_236\_65\_20170314\_00053.jpg

Looking east at garbage and prunings on landward shoulder. (Spring 2016)

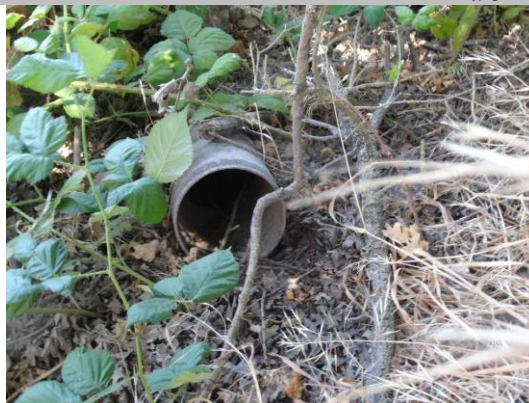
Photo 3 of 3 : UCIP\_SP\_2017\_50094\_75319.jpg

LM Start	5.13	Rating **	U	Issue No.	240 (cont)
LM End	5.13	Issue Type +	En	Location *	WS
Category	Supplemental			GPS Latitude/Longitude	
				Start	End
Item	DWR UCIP Field Study			38.380523 °	38.380523 °
				-121.541186 °	-121.541186 °
DWR ID					
Comment Code					
Inspector Comment					
FS_ID:50094 DS_ID:22856 EP_NO: N/A Repair Type: Urgent Crossing Status: Found UCIP Comments: 07/07/2016 - Pipe open on WS. no pipe or appurtenances visible on LS. pipe on WS slope below open penetration noted. May have previously been connected. (T. Hatch/UCIP)06/28/2013 - Pipe abandoned and should be done so properly. Pipe open on waterside. (W. Wylie/UCIP) FIELD_STRUCT_DESC: *ABANDONED* 7-inch steel irrigation pipe through the levee, 6.5 feet below the crown. [Additional Reference(s): DWR Levee Log, 1992. USACE Sacramento O&M Manual 113 Revised, October 1966 (LM 5.31)]. FS Date: 7/7/2016

pipe on WS slope of levee below pipe penetrating levee. May have previously been connected.

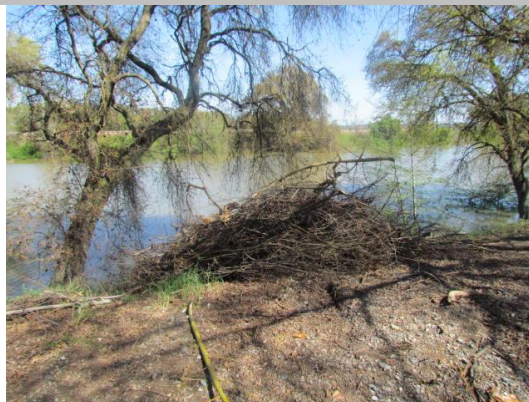
Photo 1 of 1 : SP\_2017\_RD0999\_236\_214\_20170314\_00152.jpg

LM Start	5.31	Rating **	M	Issue No.	214
LM End	5.31	Issue Type +	En	Location *	WS
Category	Earthen Levee			GPS Latitude/Longitude	
				Start	End
Item	Encroachments			38.381178 °	38.381178 °
				-121.544193 °	-121.544193 °
DWR ID	DWR_RD0999_05_s_2016_214				
Comment Code					
PR : Prunings					
Inspector Comment					
Pruning pile on waterward slope.

Looking southeast at prunings on waterward shoulder.

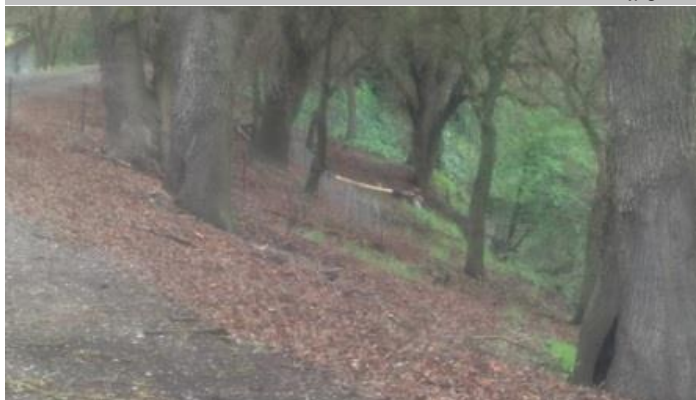
Photo 1 of 1 : SP\_2017\_RD0999\_236\_51\_20170314\_00045.jpg

LM Start	5.38	Rating **	M	Issue No.	51
LM End	5.42	Issue Type +	En	Location *	WS
Category	Earthen Levee			GPS Latitude/Longitude	
				Start	End
Item	Encroachments			38.381490 °	38.381795 °
				-121.545477 °	-121.545996 °
DWR ID	DWR_RD0999_05_s _ 2012_51				
Comment Code					
FE : Fence					
Inspector Comment					
Fence is installed down waterside slope.

Looking northeast at fence on waterside slope.

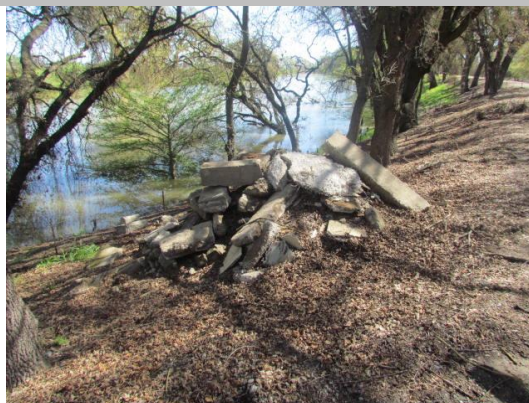
Photo 1 of 1 : SP\_2017\_RD0999\_236\_215\_20170314\_000153.jpg

LM Start	5.41	Rating **	M	Issue No.	215
LM End	5.41	Issue Type +	Ma	Location *	WS
Category	Earthen Levee			GPS Latitude/Longitude	
				Start	End
Item	Encroachments			38.381763 °	38.381763 °
				-121.545904 °	-121.545904 °
DWR ID	DWR_RD0999_05_s _ 2016_215				
Comment Code					
MA : Material					
Inspector Comment					
Concrete piled on waterward shoulder and slope

Looking southeast at concrete rubble piled on waterward shoulder.

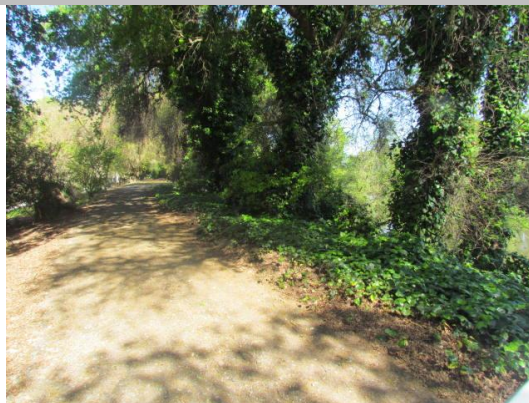
Photo 1 of 2 : SP\_2017\_RD0999\_236\_43\_20170314\_00035.jpg

LM Start	5.42	Rating **	U	Issue No.	43
LM End	5.44	Issue Type +	En	Location *	WS
Category	Earthen Levee			GPS Latitude/Longitude	
				Start	End
Item	Vegetation			38.381815 °	38.382137 °
				-121.546058 °	-121.546338 °
DWR ID	DWR_RD0999_05_s _ 2012_43				
Comment Code					
V6 : Landscaping					
Inspector Comment					
Ground cover blocking view of waterward slope.

Looking north at dense groundcover and vegetation on waterward slope.  
(Spring 2015)

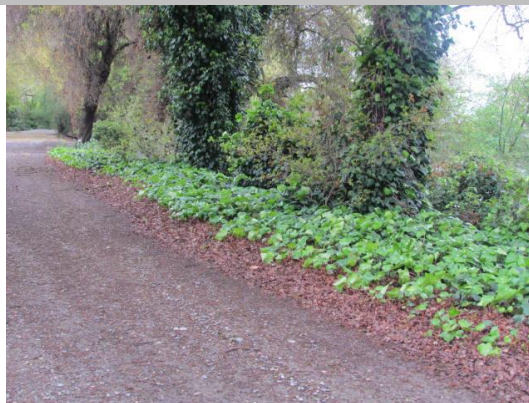
Photo 2 of 2 : SP\_2017\_RD0999\_236\_43\_20170314\_00036.jpg

LM Start	5.42	Rating **	U	Issue No.	43 (cont)	
LM End	5.44	Issue Type +	En	Location *	WS	
Category	Earthen Levee			GPS Latitude/Longitude		
				Start		End
Item	Vegetation			38.381815 °		38.382137 °
				-121.546058 °		-121.546338 °
DWR ID	DWR_RD0999_05_s_2012_43					
Comment Code						
V6 : Landscaping						
Inspector Comment						
Ground cover blocking view of waterward slope.

Looking northeast at dense groundcover and vegetation on waterside slope.

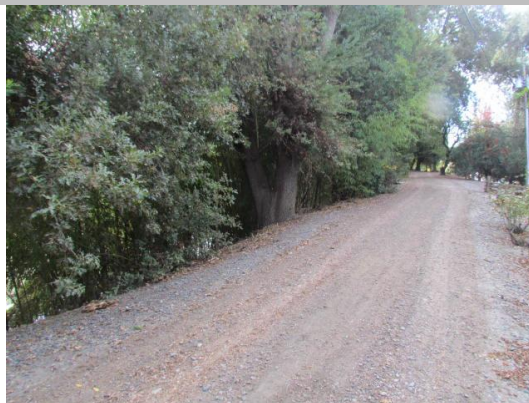
Photo 1 of 1 : SP\_2017\_RD0999\_236\_67\_20170314\_00056.jpg

LM Start	5.47	Rating **	U	Issue No.	67
LM End	5.52	Issue Type +	Ma	Location *	WS
Category	Earthen Levee			GPS Latitude/Longitude	
				Start	End
Item	Trim / Thin Trees			38.382454°	38.383141°
				-121.546579°	-121.546870°
DWR ID	DWR_RD0999_05_s_2012_67				
Comment Code					
T1 : Trim trees to at least five feet above ground level.					
Inspector Comment

Looking north at dense vegetation on landward shoulder and slope.

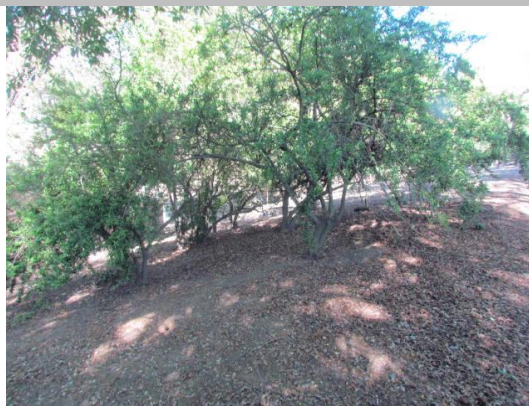
Photo 1 of 1 : SP\_2017\_RD0999\_236\_68\_20170314\_00057.jpg

LM Start	5.48	Rating **	M	Issue No.	68
LM End	5.48	Issue Type +	Ma	Location *	LS
Category	Earthen Levee			GPS Latitude/Longitude	
				Start	End
Item	Trim / Thin Trees			38.382553 °	38.382553 °
				-121.546651 °	-121.546651 °
DWR ID	DWR_RD0999_05_s_2012_68				
Comment Code					
T1 : Trim trees to at least five feet above ground level.					
Inspector Comment

Looking northeast at untrimmed trees on landward slope. (Spring 2015)

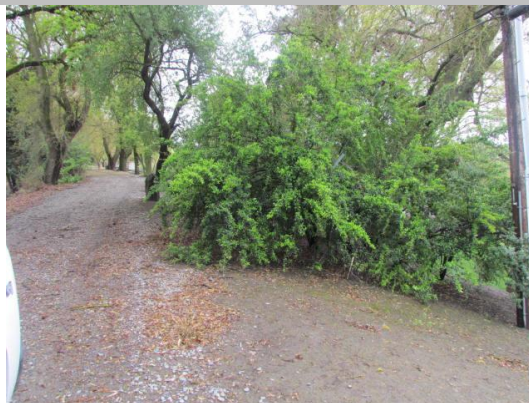
Photo 1 of 1 : SP\_2017\_RD0999\_236\_70\_20170314\_00058.jpg

LM Start	5.49	Rating **	M	Issue No.	70
LM End	5.49	Issue Type +	Ma	Location *	LS
Category	Earthen Levee			GPS Latitude/Longitude	
				Start	End
Item	Trim / Thin Trees			38.382698 °	38.382698 °
				-121.546711 °	-121.546711 °
DWR ID	DWR_RD0999_05_s_2012_70				
Comment Code					
T3 : Trim and thin trees to allow visibility of the ground and room to flood fight.					
Inspector Comment

Looking southwest at untrimmed tree on waterside shoulder and slope.

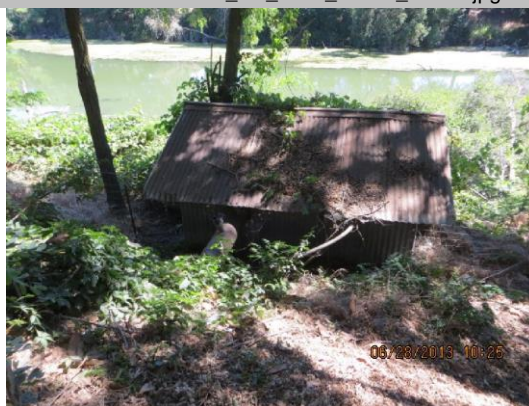
Photo 2 of 3 : UCIP\_SP\_2017\_15446\_25365.jpg

LM Start	5.50	Rating **	M	Issue No.	242 (cont)	
LM End	5.50	Issue Type +	En	Location *	WS	
Category	Supplemental			GPS Latitude/Longitude		
				Start		End
Item	DWR UCIP Field Study			38.382821 °		38.382821 °
				-121.546661 °		-121.546661 °
DWR ID						
Comment Code						
Inspector Comment						
FS_ID:15446 DS_ID:22857 EP_NO: N/A Repair Type: Non-Urgent Crossing Status: Found UCIP Comments: Pipe appears abandoned and should be done so appropriately. FIELD_STRUCT_DESC: 10-inch steel irrigation pipe through the levee 4-feet below the crown. Pumphouse and gate valve on the waterward slope. Vent on LS slope and a 42-inch concrete standpipe on LS toe. service pole on the landward slope with a 1.5-inch galvanized iron electrical conduit at same location. Originally included in the 1966 O&M manual. FS Date: 6/28/2013

Corrugated metal pumphouse on WS slope.

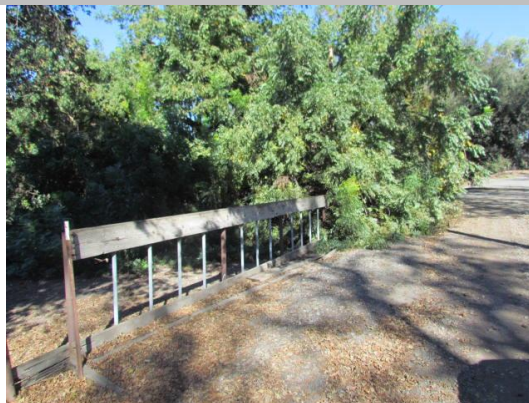
Photo 1 of 1 : SP\_2017\_RD0999\_236\_203\_20170314\_00143.jpg

LM Start	5.56	Rating **	A/W	Issue No.	203
LM End	5.61	Issue Type +	Ma	Location *	LS
Category	Earthen Levee			GPS Latitude/Longitude	
				Start	End
Item	Trim / Thin Trees			38.383740 °	38.384218 °
				-121.546628 °	-121.546095 °
DWR ID	DWR_RD0999_05_f_2014_203				
Comment Code					
T1 : Trim trees to at least five feet above ground level.					
Inspector Comment

Looking at untrimmed trees on landward slope and toe.

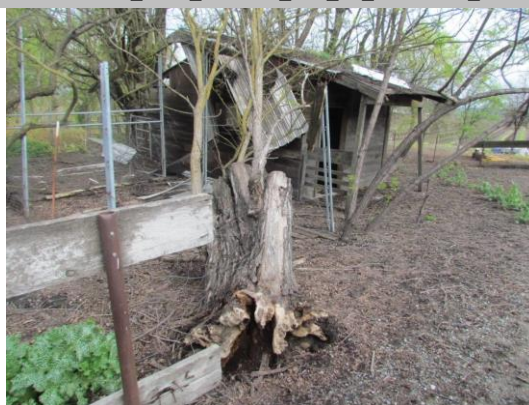
Photo 1 of 2 : SP\_2017\_RD0999\_236\_37\_20170324\_00244.jpg

LM Start	5.57	Rating **	U	Issue No.	37
LM End	5.57	Issue Type +	En	Location *	LS
Category	Earthen Levee			GPS Latitude/Longitude	
				Start	End
Item	Encroachments			38.383780 °	38.383780 °
				-121.546590 °	-121.546590 °
DWR ID	DWR_RD0999_05_s_2017_37				
Comment Code					
BU : Building					
Inspector Comment					
Dilapidated horse pen on waterward slope and fallen tree.

Looking northwest at dilapidated horse pen and fallen tree on landward slope.

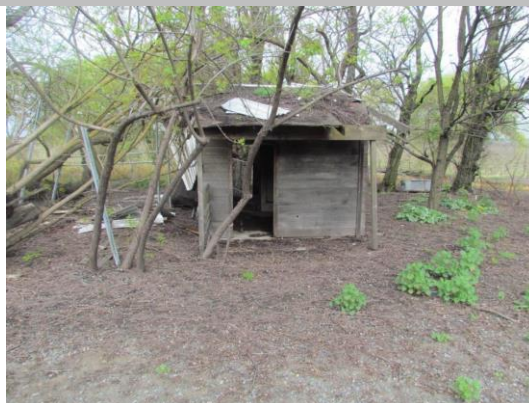
Photo 2 of 2 : SP\_2017\_RD0999\_236\_37\_20170324\_00245.jpg

LM Start	<b>5.57</b>	Rating **	U	Issue No.	<b>37 (cont)</b>
LM End	<b>5.57</b>	Issue Type +	En	Location *	LS

Looking west at dilapidated horse pen and fallen tree on landward slope.

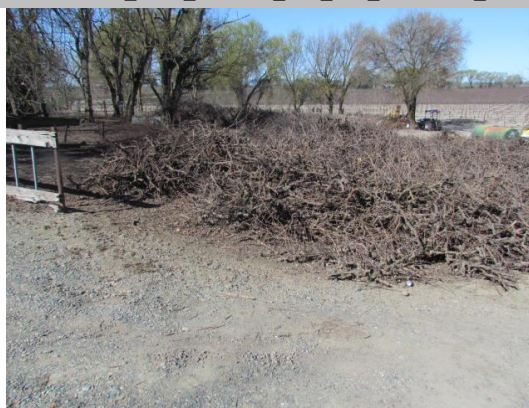
Photo 1 of 1 : SP\_2017\_RD0999\_236\_192\_20170314\_00132.jpg

LM Start	5.58	Rating **	A/W	Issue No.	192
LM End	5.58	Issue Type +	Ma	Location *	LS
Category	Earthen Levee			GPS Latitude/Longitude	
				Start	End
Item	Encroachments			38.383978 °	38.383978 °
				-121.546435 °	-121.546435 °
DWR ID	DWR_RD0999_05_s_2014_192				
Comment Code					
PR : Prunings					
Inspector Comment					
Landowner pile prunings on landside slope.

Looking west at prunings on landward slope and toe.

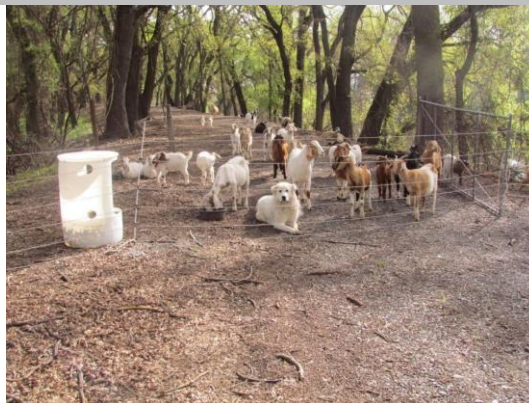
Photo 1 of 2 : SP\_2017\_RD0999\_236\_138\_20170324\_00246.jpg

LM Start	5.80	Rating **	U	Issue No.	138
LM End	6.01	Issue Type +	En	Location *	CR
Category	Earthen Levee			GPS Latitude/Longitude	
				Start	End
Item	Encroachments			38.384682 °	38.386723 °
				-121.542713 °	-121.541340 °
DWR ID	DWR_RD0999_05_s_2017_138				
Comment Code					
FE : Fence					
Inspector Comment					
Could not pass through due to animal (goats) fence across levee crown.

Looking downstream at fence and goats blocking access to levee.

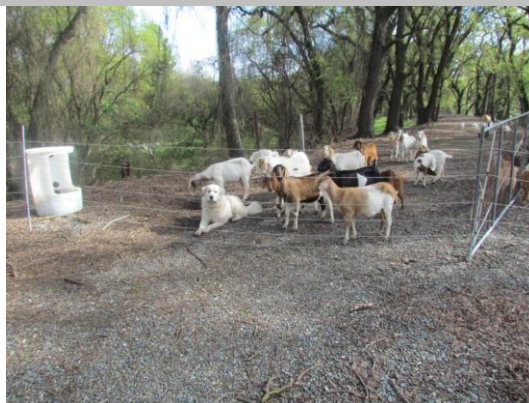
Photo 2 of 2 : SP\_2017\_RD0999\_236\_138\_20170324\_00247.jpg

LM Start	<b>5.80</b>	Rating **	U	Issue No.	<b>138 (cont)</b>
LM End	<b>6.01</b>	Issue Type +	En	Location *	CR

Looking west at fence and goats blocking access to levee

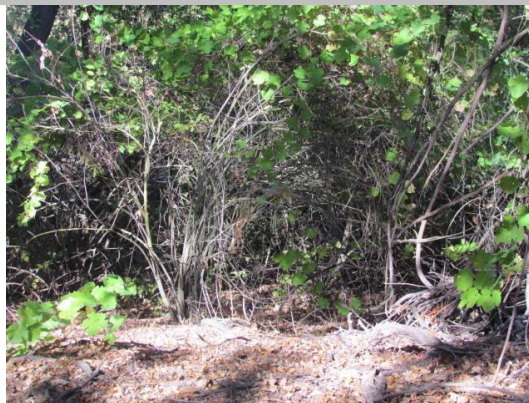
Photo 1 of 2 : SP\_2017\_RD0999\_236\_48\_20170314\_00042.jpg

LM Start	5.80	Rating **	A/W	Issue No.	48
LM End	5.84	Issue Type +	Ma	Location *	LS
Category	Earthen Levee			GPS Latitude/Longitude	
				Start	End
Item	Vegetation			38.384718 °	38.384930 °
				-121.542590 °	-121.541883 °
DWR ID	DWR_RD0999_05_s_2012_48				
Comment Code					
V2 : Remove the wild growth other than native grasses from the levee slopes.					
Inspector Comment					
Dense vegetation at landward slope and toe.

Looking west at dense vegetation on landward slope and toe. Fall 2015

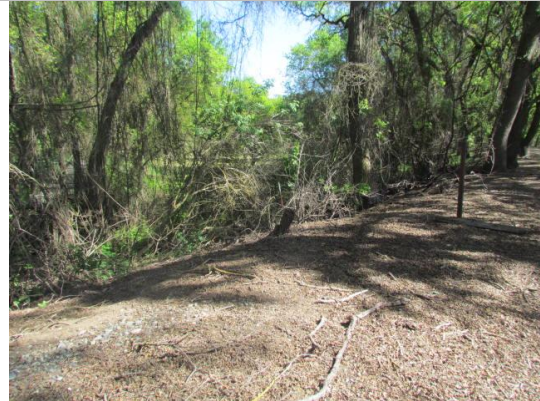
Photo 2 of 2 : SP\_2017\_RD0999\_236\_48\_20170314\_00043.jpg

LM Start	5.80	Rating **	A/W	Issue No.	48 (cont)	
LM End	5.84	Issue Type +	Ma	Location *	LS	
Category	Earthen Levee			GPS Latitude/Longitude		
				Start	End	
Item	Vegetation			38.384718 °	38.384930 °	
				-121.542590 °	-121.541883 °	
DWR ID	DWR_RD0999_05_s_2012_48					
Comment Code						
V2 : Remove the wild growth other than native grasses from the levee slopes.						
Inspector Comment						
Dense vegetation at landward slope and toe.

Looking east at dense vegetation on landward slope. (Spring 2015)

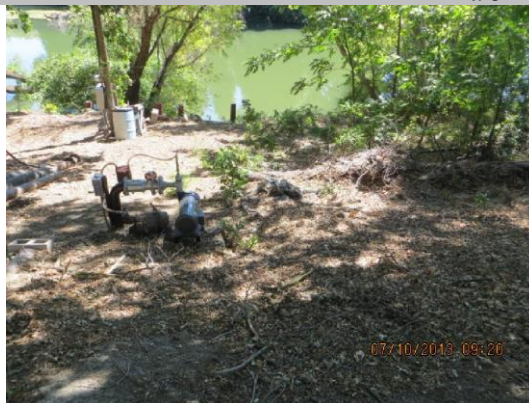
Photo 1 of 3 : UCIP\_SP\_2017\_40791\_27555.jpg

LM Start	6.13	Rating **	M	Issue No.	243
LM End	6.13	Issue Type +	En	Location *	LS
Category	Supplemental			GPS Latitude/Longitude	
				Start	End
Item	DWR UCIP Field Study			38.388151 °	38.388151 °
				-121.542624 °	-121.542624 °
DWR ID					
Comment Code					
Inspector Comment					
FS_ID:40791					
DS_ID:22890					
EP_NO: N/A					
Repair Type: Non-Urgent					
Crossing Status: Found					
UCIP Comments: No permit identified for crossing. Settlement over pipe alignment on crown.					
FIELD_STRUCT_DESC: 4-inch steel irrigation pipe through the levee 1.5-feet below the crown. Pump on WS. Filter, booster, and vent on LS toe. JP on WS shoulder.					
FS Date: 7/10/2013

Pump on WS slope.

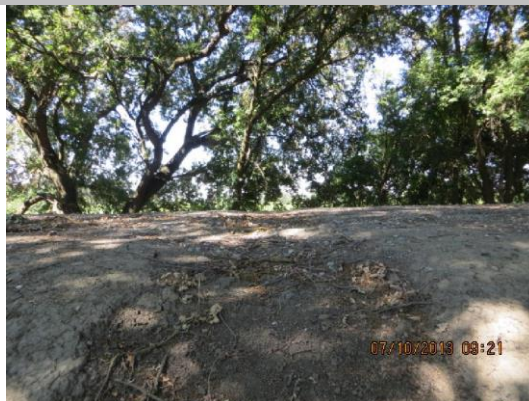
Photo 2 of 3 : UCIP\_SP\_2017\_40791\_27554.jpg

LM Start	<b>6.13</b>	Rating **	M	Issue No.	<b>243 (cont)</b>
LM End	<b>6.13</b>	Issue Type +	En	Location *	LS

Settlement along pipe alignment on crown.

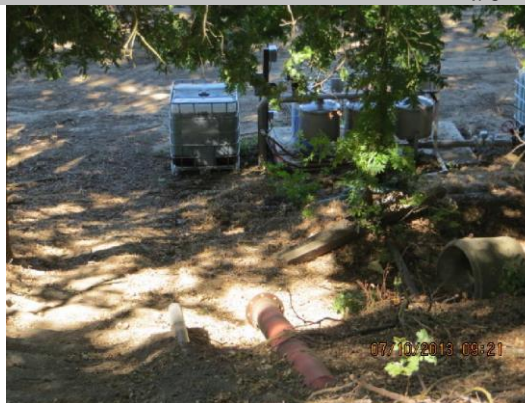
Photo 3 of 3 : UCIP\_SP\_2017\_40791\_27553.jpg

LM Start	6.13	Rating **	M	Issue No.	243 (cont)
LM End	6.13	Issue Type +	En	Location *	LS
Category	Supplemental			GPS Latitude/Longitude	
				Start	End
Item	DWR UCIP Field Study			38.388151 °	38.388151 °
				-121.542624 °	-121.542624 °
DWR ID					
Comment Code					
Inspector Comment					
FS_ID:40791					
DS_ID:22890					
EP_NO: N/A					
Repair Type: Non-Urgent					
Crossing Status: Found					
UCIP Comments: No permit identified for crossing. Settlement over pipe alignment on crown.					
FIELD_STRUCT_DESC: 4-inch steel irrigation pipe through the levee 1.5-feet below the crown. Pump on WS. Filter, booster, and vent on LS toe. JP on WS shoulder.					
FS Date: 7/10/2013

Pipe visible on LS slope with filter plant in background.

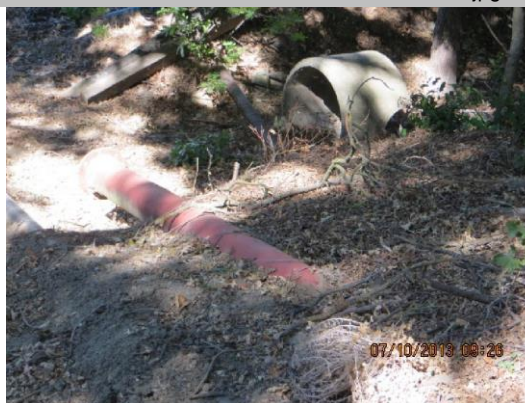
Photo 1 of 3 : UCIP\_SP\_2017\_50095\_25859.jpg

LM Start	6.13	Rating **	U	Issue No.	244
LM End	6.13	Issue Type +	En	Location *	LS
Category	Supplemental			GPS Latitude/Longitude	
				Start	End
Item	DWR UCIP Field Study			38.388175 °	38.388175 °
				-121.542623 °	-121.542623 °
DWR ID

Comment Code					
Inspector Comment					
FS_ID:50095 DS_ID:22859 EP_NO: N/A Repair Type: Urgent Crossing Status: Found UCIP Comments: 07/07/2016 - slant pump intake located on WS toe with the opening blocked by cinder blocks. multiple pipes segments laying on WS slope. Otherwise, no change from previous inspection. (T. Hatch/UCIP)07/10/2013 - Pipe appears abandoned and is open on both ends. Pipe should be abandoned properly. (W. Wylie/UCIP) FIELD_STRUCT_DESC: 6-inch steel irrigation pipe through the levee, 6 feet below the crown. Evidence of Pump, gate valve on the WS toe along with a service pole. Evidence of a 36-inch standpipe at the landward toe. [Additional Reference(s): DWR Levee Log, 1992. USACE Sacramento O&M Manual 113 Revised, October 1966 (LM 6.29)]. FS Date: 7/7/2016

6-inch steel pipe on LS slope with evidence of 36-inch standpipe in background.

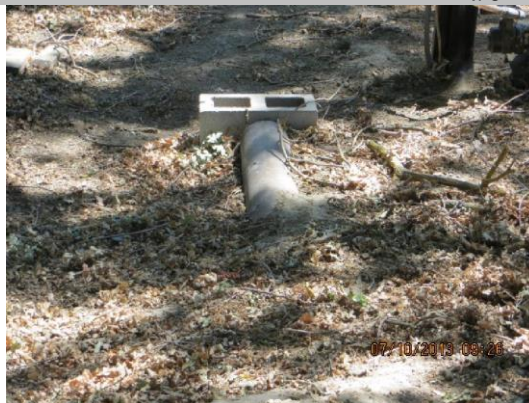
Photo 2 of 3 : UCIP\_SP\_2017\_50095\_25858.jpg

Item	DWR UCIP Field Study			38.388175 °		38.388175 °
				-121.542623 °		-121.542623 °
DWR ID						
Comment Code						
Inspector Comment						
FS_ID:50095 DS_ID:22859 EP_NO: N/A Repair Type: Urgent Crossing Status: Found UCIP Comments: 07/07/2016 - slant pump intake located on WS toe with the opening blocked by cinder blocks. multiple pipes segments laying on WS slope. Otherwise, no change from previous inspection. (T. Hatch/UCIP)07/10/2013 - Pipe appears abandoned and is open on both ends. Pipe should be abandoned properly. (W. Wylie/UCIP) FIELD_STRUCT_DESC: 6-inch steel irrigation pipe through the levee, 6 feet below the crown. Evidence of Pump, gate valve on the WS toe along with a service pole. Evidence of a 36-inch standpipe at the landward toe. [Additional Reference(s): DWR Levee Log, 1992. USACE Sacramento O&M Manual 113 Revised, October 1966 (LM 6.29)]. FS Date: 7/7/2016

Pipe visible on WS slope.

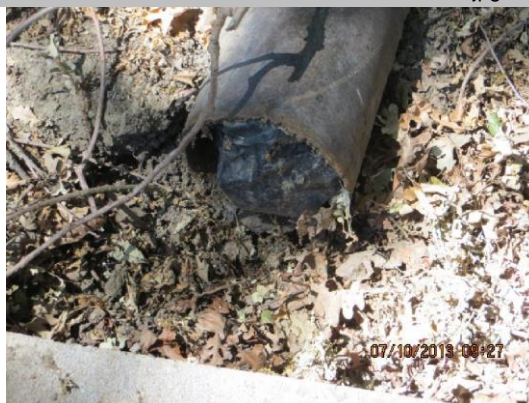
Photo 3 of 3 : UCIP\_SP\_2017\_50095\_25857.jpg

LM Start	<b>6.13</b>	Rating **	U	Issue No.	<b>244 (cont)</b>
LM End	<b>6.13</b>	Issue Type +	En	Location *	LS

Pipe open on WS slope.

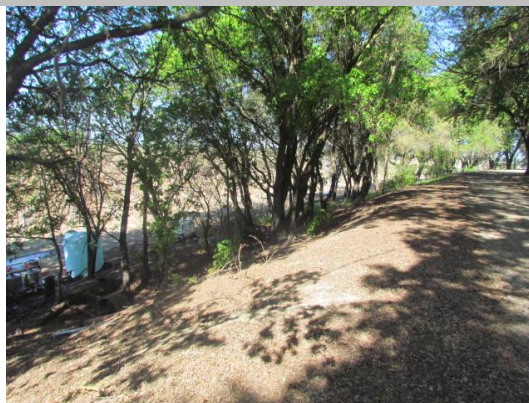
Photo 1 of 1 : SP\_2017\_RD0999\_236\_60\_20170314\_00051.jpg

LM Start	6.13	Rating **	M	Issue No.	60
LM End	6.13	Issue Type +	Ma	Location *	LS
Category	Earthen Levee			GPS Latitude/Longitude	
				Start	End
Item	Trim / Thin Trees			38.388225 °	38.388225 °
				-121.542697 °	-121.542697 °
DWR ID	DWR_RD0999_05_s_2012_60				
Comment Code					
T3 : Trim and thin trees to allow visibility of the ground and room to flood fight.					
Inspector Comment

Looking north at dense trees on landward slope. (Spring 2015)

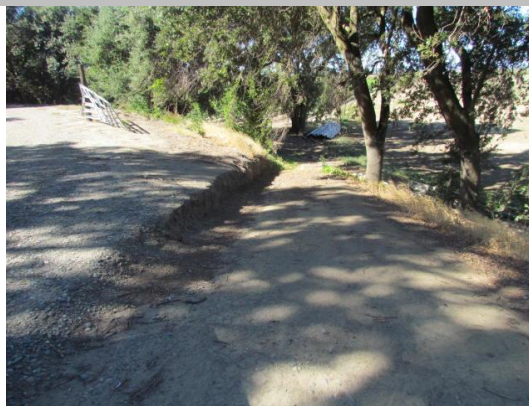
Photo 1 of 1 : SP\_2017\_RD0999\_236\_155\_20170314\_00104.jpg

LM Start	6.26	Rating **	M	Issue No.	155
LM End	6.26	Issue Type +	En	Location *	LS
Category	Earthen Levee			GPS Latitude/Longitude	
				Start	End
Item	Encroachments			38.389946 °	38.389946 °
				-121.542461 °	-121.542461 °
DWR ID	DWR_RD0999_05_f_2013_155				
Comment Code					
RA : Ramp					
Inspector Comment					
Unauthorized ramp on landward slope.

Looking southwest at ramp on landward slope.
